# **Lake Cadillac 2021 Aquatic Vegetation, Water Quality, and 2022 Management Recommendations Annual Report**

**January, 2022**

**© Restorative Lake Sciences  
18406 Spring Lake Road  
Spring Lake, Michigan 49456  
Website: <http://www.restorativelakesciences.com>**

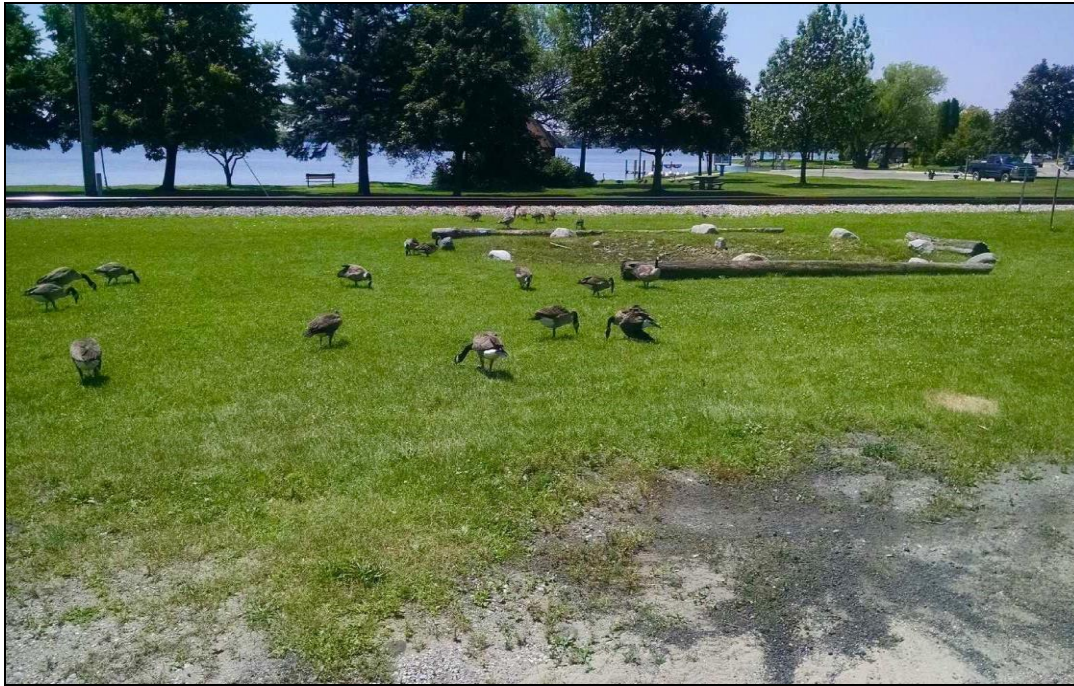
As in recent years, during the 2021 season, RLS noted that there is an abundance of geese around the parks on Lake Cadillac (Figure 10). A study by Manny et al. (1994) found that the annual contribution of carbon, nitrogen, and phosphorus from migratory waterfowl including Canada geese (*Branta canadensis*) can exceed the external loading contributions on some inland lakes. Thus, an overabundance of geese can lead to increased nutrient loads to Lake Cadillac. Fortunately, there are some strategies for reducing geese populations which include but are not limited to the following:

**Figure 10. An over-abundance of Canada geese near the shore of Lake Cadillac during the 2017-2021 season.**

1. Encourage riparians to grow waterfront grass to  $\geq 3$  inches tall as geese prefer short grass.
2. Plant tall native plants near the shore to encourage a soft shoreline that geese may avoid due to the potential of predators hiding in the tall weeds.
3. Avoid mowing to the water's edge.
4. Do not feed geese or waterfowl as this encourages their presence.
5. Egg replacement, goose round-up, and nest destruction methods are effective to a degree but require an MDNR permit and training.
6. Coyote or other intimidating effigies can scare geese away from lawns.
7. The Audubon Society recommends placement of string 6 inches above the ground followed by another row of string an additional 6 inches above the water.
8. Visit the following website for more methods:  
<http://icwdm.org/handbook/Birds/CanadadGeese/Default.aspx>
